# Manhole Inspection Summary

Manhole # S37C\_\_047MH

**Location** Address: **218 fallsway**

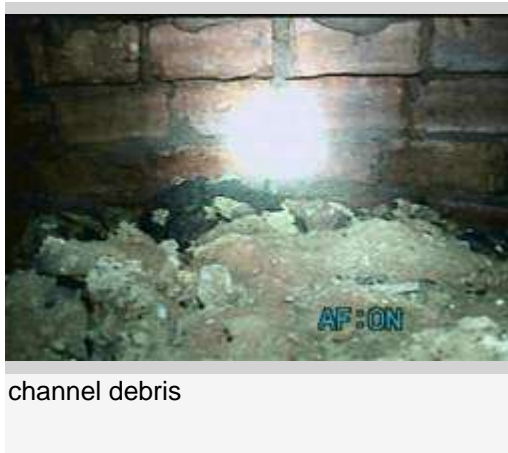
Defect 5

Condition: ☐ Sound ☐ Cracked ☐ Root Intrusion ☐ Deteriorated ☐ Leaks ☒ **Debris**

channel debris

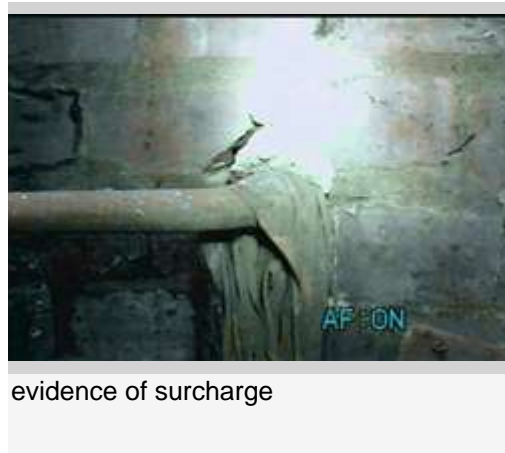
Defect 4

**Surcharge** ☒ **Evidence Of Surcharge** Depth: **6.5** (ft.) ☐ Active Surcharge Present

evidence of surcharge

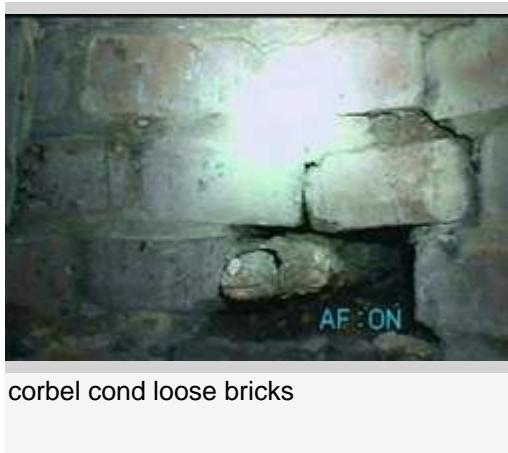
Defect 3

Condition: ☐ Sound ☒ **Cracked** ☐ Root Intrusion ☒ **Loose Brick** ☐ Deteriorated

corbel cond loose bricks

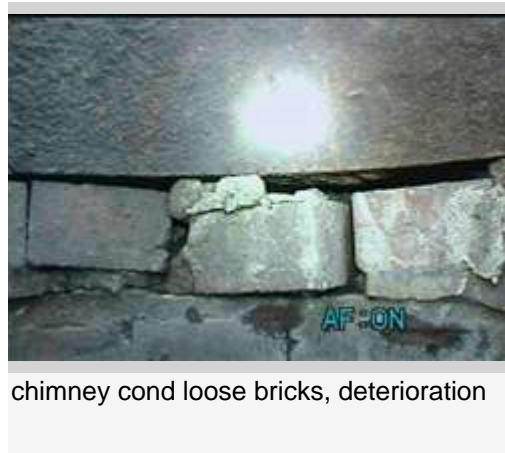
Defect 2

Condition: ☐ Sound ☒ **Cracked** ☐ Root Intrusion ☒ **Loose Brick** ☐ Deteriorated

chimney cond loose bricks, deterioration

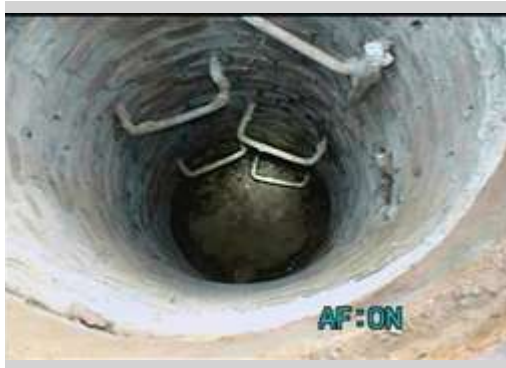
### Defect 1

**Steps** Count: **5** Missing: **0** ☒ **Corroded**

steps

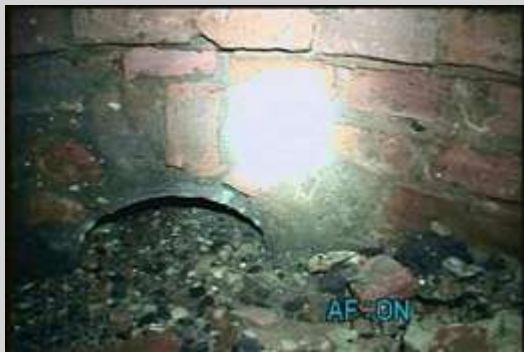
12 O'Clock Outflow

8 in. Circular Gravity Sewer  
Pipe Out @ 12 O'Clock

Deposits: ☐ None ☐ Mud ☐ Sludge ☒ **Debris** ☐ Grease

Silt Depth: **4** (in.) Deposits Extent: **Medium**
